Home Inspection
Prepared for: Rich and Dayna Lee

8/11/2006

128 Palo Verde Court
Sonoma, CA 95476

Valley Inspections
(707) 332-0030

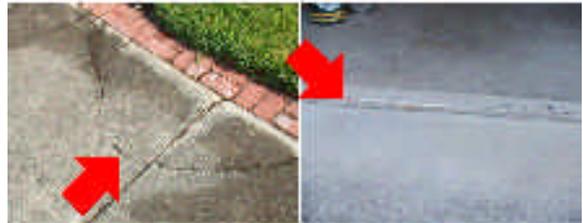
Fair condition. Concrete and/or concrete block. Cracks were noted that are larger than typical. Patching is recommended to prevent any further damage from happening. **Tripping hazards were noted** at the driveway to garage slab transition (where there is an abrupt change of 1" or more in the height of the surface). Caution should be taken when walking in these areas.

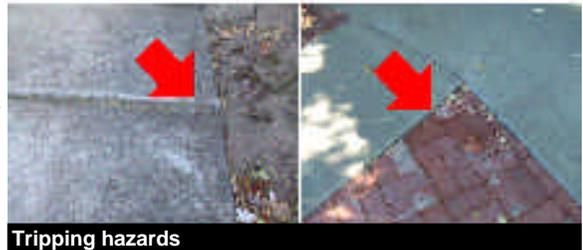
WALKWAYS:

Fair condition. Concrete. Normal settling cracks were noted. All concrete, asphalt, and masonry cracks (it's just a matter of degree), and the cracks observed appear to be normal compared to the age of the material. The life expectancy of driveway and sidewalk paving is about 40 to 50 years depending on the usage. **Tripping hazards were noted** (where there is an abrupt change of 1" or more in the height of the surface). Caution should be taken when walking in these areas.

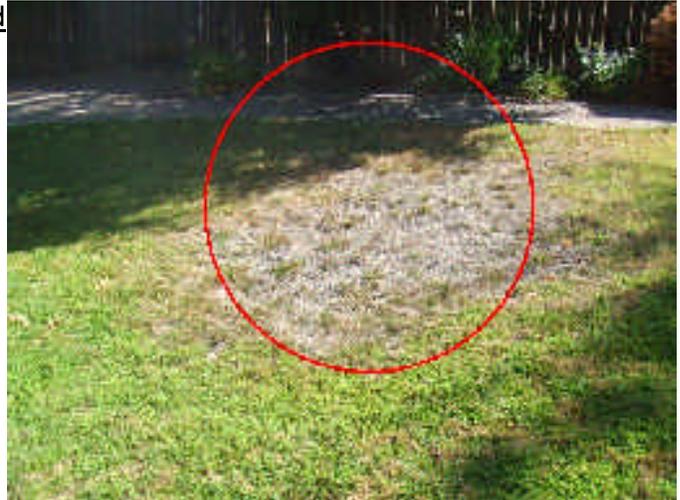
Routine Scheduled Maintenance is currently needed.
Dry/dead areas were noted.

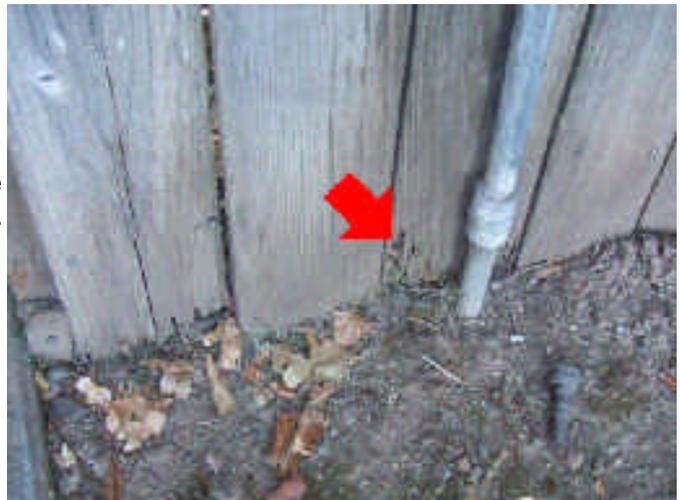
Earth to wood contact is noted.
This condition is common but will accelerate the deterioration of the wood components.

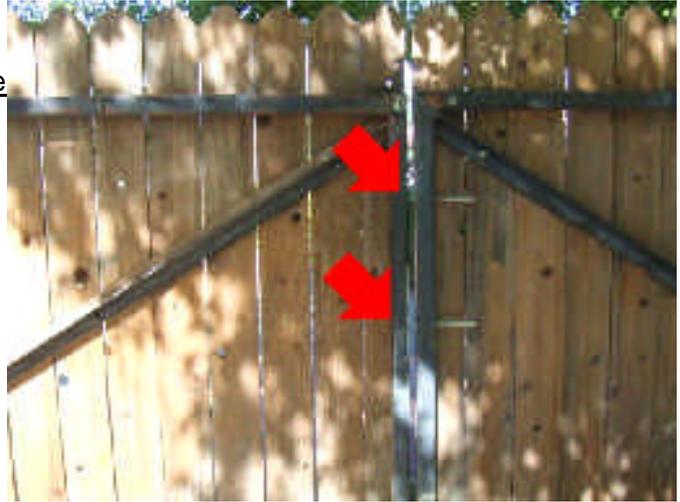
Fair condition. The gate material is wood. At least one of the gates are in need of repair or adjustment on the left side. They are sagging and causing poor operation.

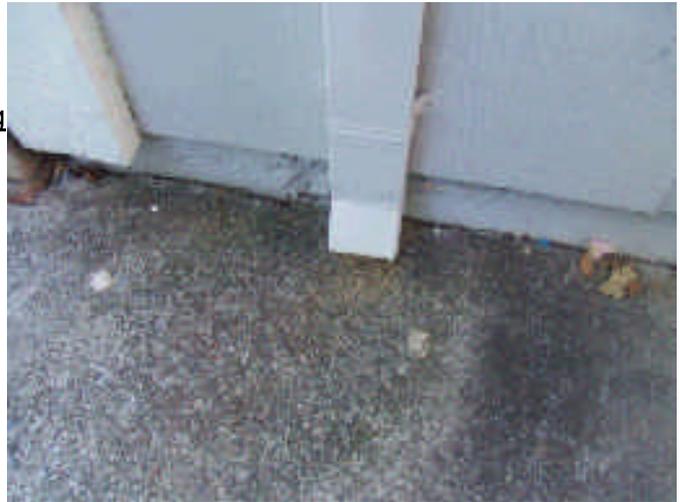
SITE GRADING:

Areas of the perimeter around the home were noted to be sloping towards building. To reduce any potential adverse effects from this condition, reasonable efforts should be made to divert run-off away from the foundation as practical.

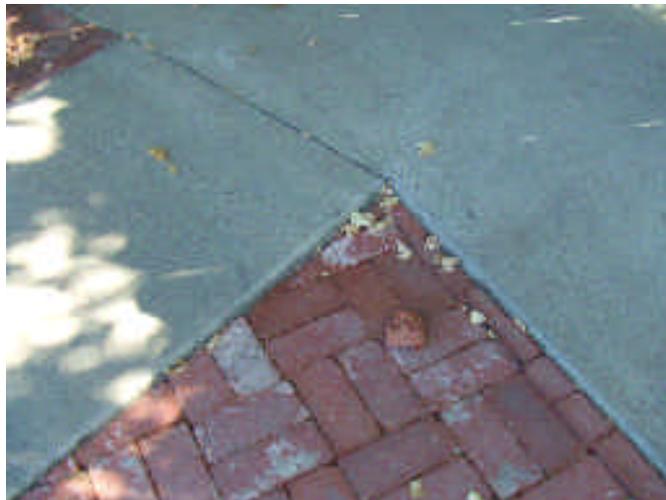
Fair condition.
Rear side. Brick.
Surface is raised/
settled in some
areas and may
present a
**potential tripping
hazard** over time.
Repairs are
recommended.

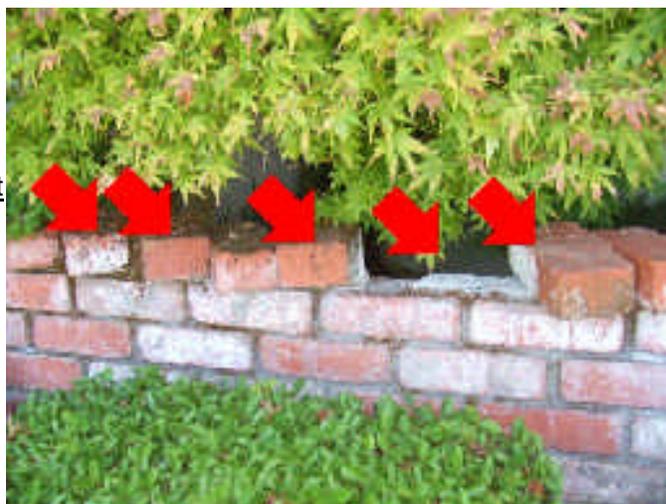
The top layer of bricks were loose and not fully mortared into the wall at the front porch. We recommend that they be reattached to prevent any potential hazards.

NOTE: The top layer of bricks were loose and not fully mortared into the wall. We recommend that they be reattached to prevent any potential hazards.

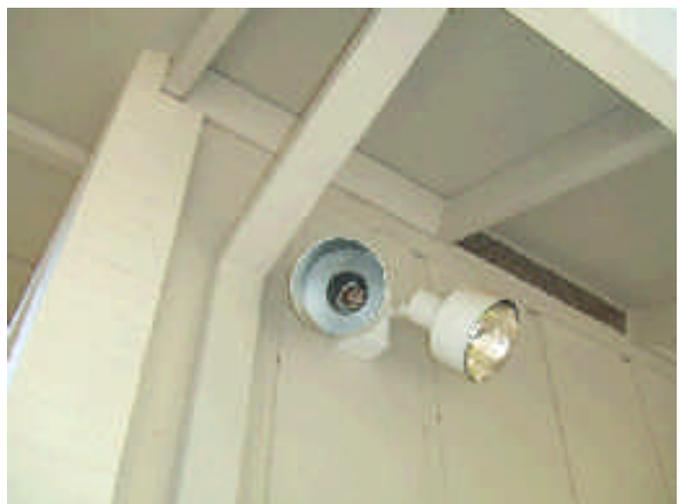
ELECTRICAL FIXTURES:

NOTE: A weatherproof light was missing at the left front corner.

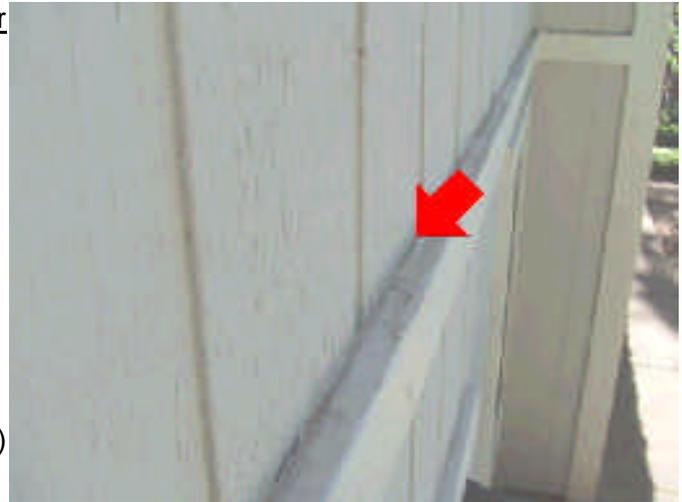
Caulk is missing or deteriorated at some siding joints and trim components. Caulking in these areas prevents moisture from getting trapped between trim and wall coverings (causing deterioration of wood components) and also acts as an air infiltration barrier.

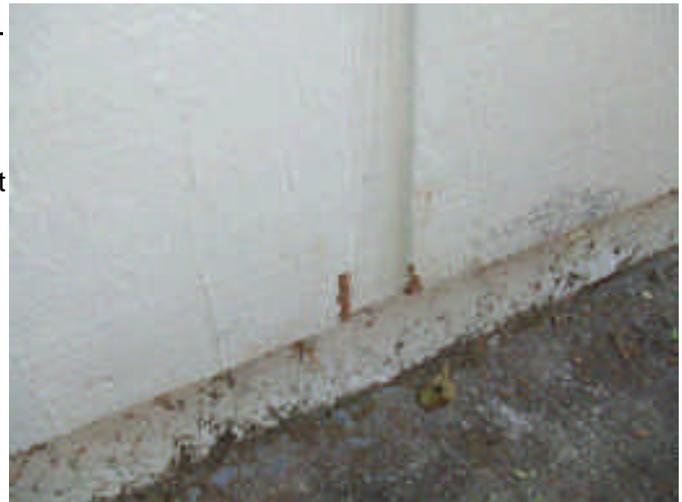
PAINT/STAIN:

Paint was missing. We recommend that all exposed wood be primed and painted to further help protect the wood from the elements.

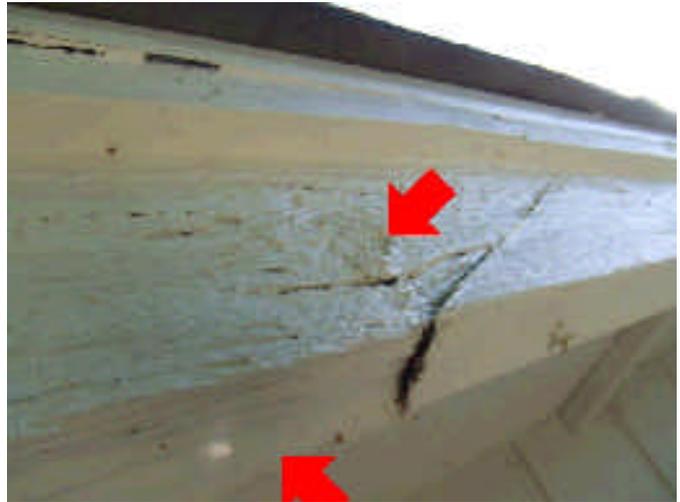
Damage was noted to the right side barge rafter. We recommend repair and replacement of all damage wood.

Fair condition.
Damage was noted to the right side barge rafter.
We recommend repair and replacement of all damage wood.

Trees or shrubs were in contact with the eave(s).
We recommend trimming back to prevent any future damage from occurring.

Regarding the damaged barge rafter and slanting hallway, we recommend that corrections be made by a licensed contractor.

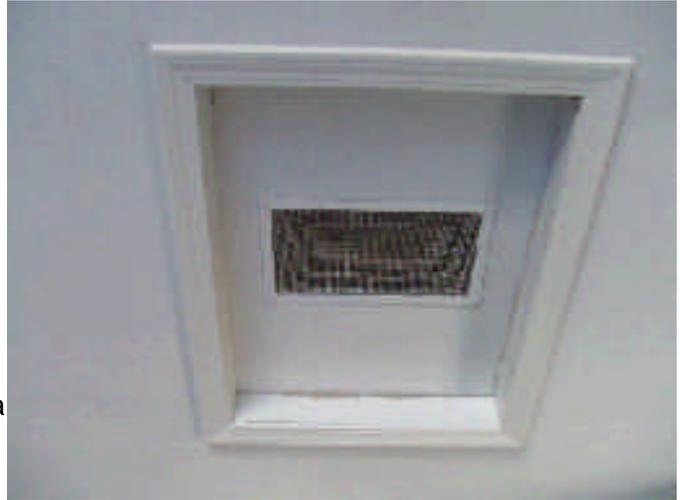
The attic door is screened and not fully sealed, which will allow a fire to spread to framing members more quickly. We recommend that the hatch be fire proofed for better protection should a fire occur in the garage.

Good to fair condition. The attic door is screened and not fully sealed. This will allow a fire to spread to framing members more quickly. e recommend that the hatch be fire proofed for better protection should a fire occur in the garage.

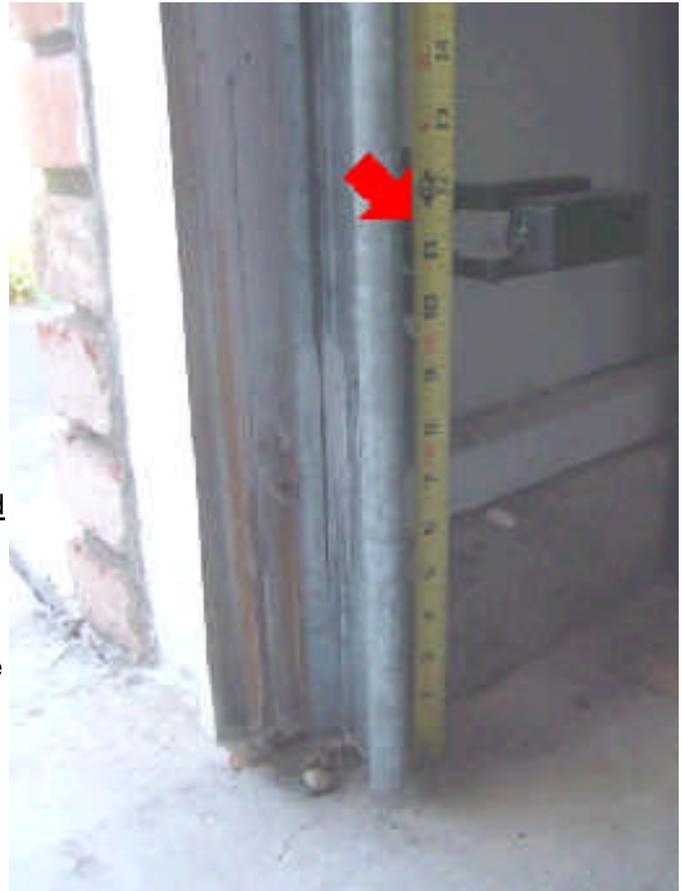
The photoelectric sensors for the garage door is operable at this time. However, the electric safety eye(s) were positioned higher than recommended and poses a **potential safety hazard** should a small child or animal crawl under it. We recommend that a qualified garage door installer correct this condition by lowering the photoelectric

sensors to the proper height as outlined in the manufacturers installation instructions of 4-6 inches. You can find out more on garage door safety by visiting the consumer product safety commission's website a <http://www.cpsc.gov/cpscpub/pubs/523.htm>.

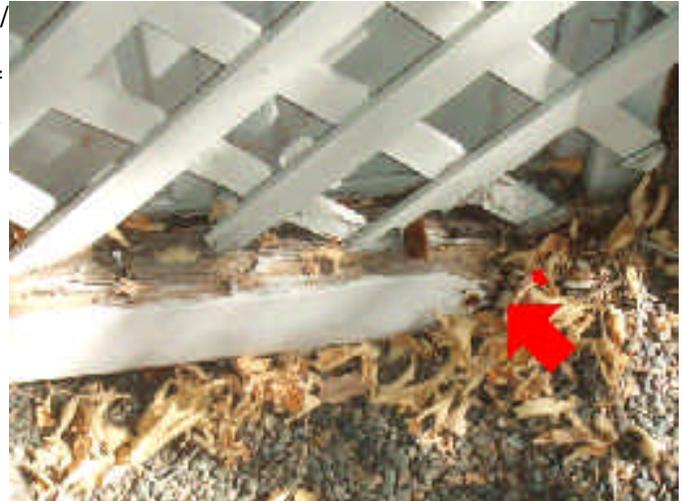
NOTE:
Deterioration was noted to the foundation of this shed.

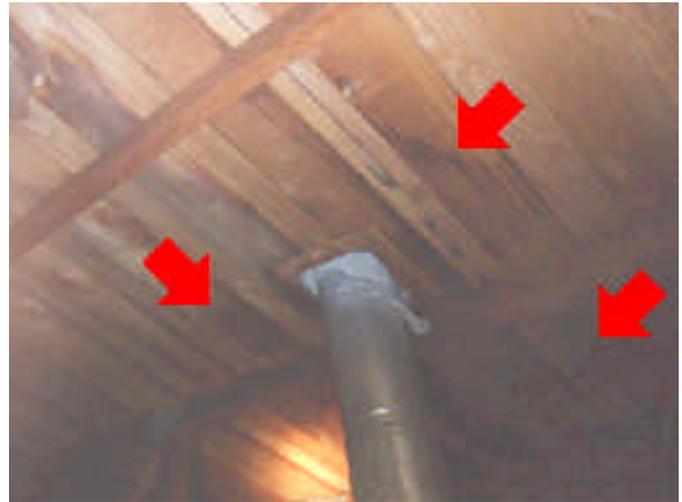
There is evidence of a prior fire near the furnace/water heater flue.

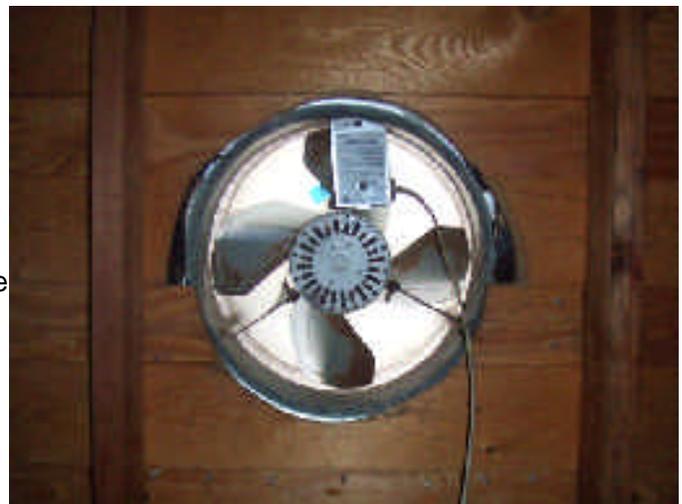
Ventilation is provided at gable end(s) and at roof. This is considered to be marginal. Additional attic ventilation is recommended. This will extend the existing life left on the roof and make for a more comfortable living space.

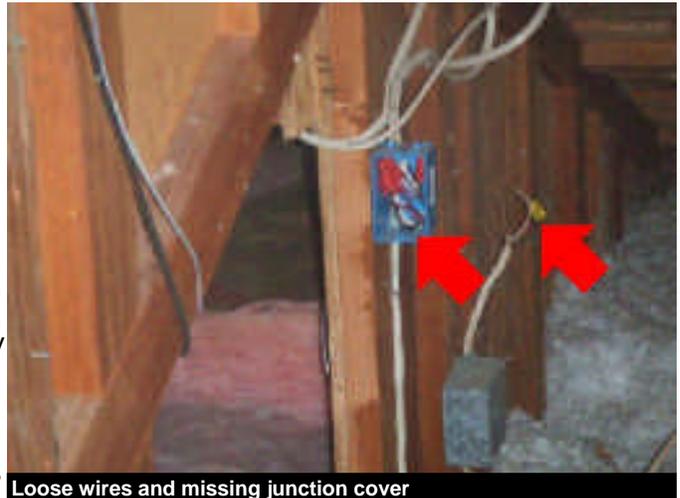
Junction box covers were missing. Covers are inexpensive to purchase and easy to install, they are very important because they contain any sparks within the box in the event that wire connections become loose.

Open junction boxes were noted in attic area. We recommend that all junction boxes be covered to prevent any open sparks from occurring. Covers are inexpensive to purchase and easy to install, they are very important because they contain any sparks within the box in the event that wire connections become loose.

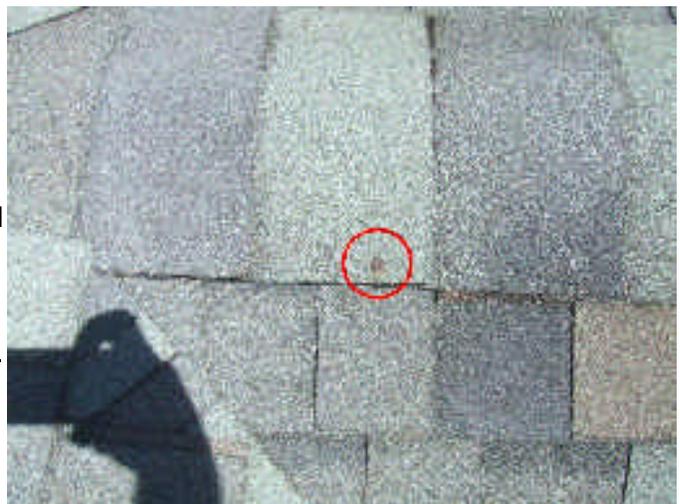
TYPE & CONDITION:

Good to fair condition. The roof covering is Architectural composition shingles (also called Dimensional composition). Nails/fasteners were noted which are exposed to the elements; these fasteners may eventually come loose or rust. We recommend that they be sealed as a preventative measure against future possible leakage.

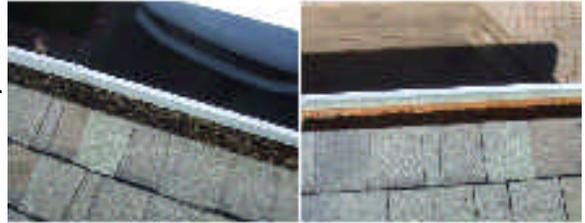
TYPE & CONDITION: Fair condition. Metal, 5" Fascia. Debris (from overhanging vegetation, mineral deposits from roof shingles, etc.) was noted in the gutters. This is a common condition, however it will accelerate the deterioration of the gutters. Gutter cleaning is a preventative maintenance procedure which should be performed at least once a year.

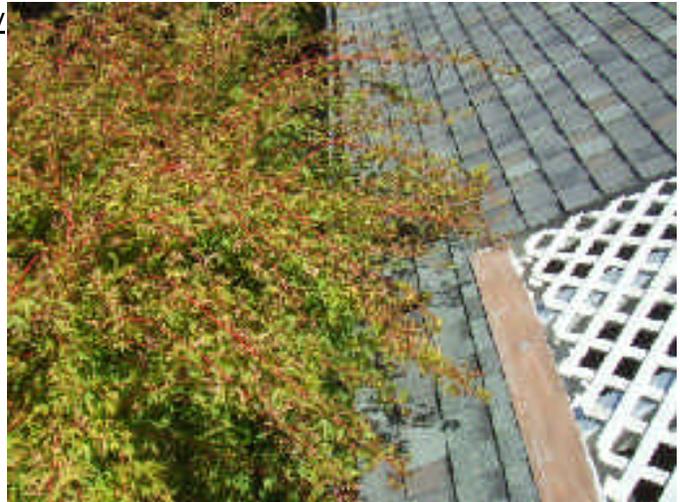
Trees or shrubbery are overhanging the roof surface. We recommend that overhanging trees be trimmed back where they are likely to come into contact with the eaves or roof surface.

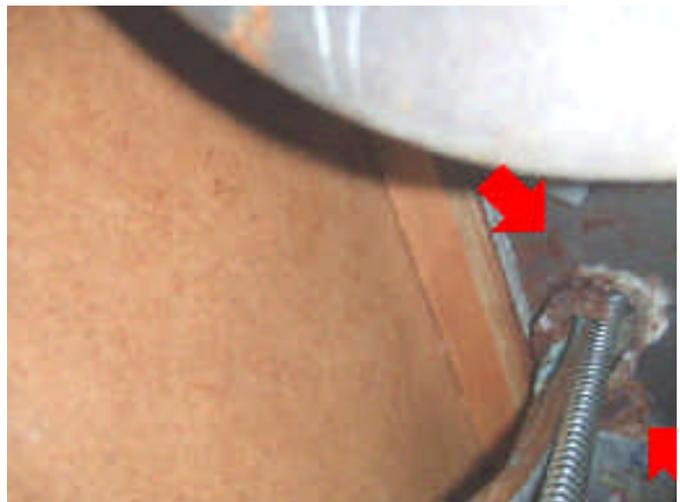
Corrosion was noted under the faucet. A licensed plumber should be called to make further evaluation and repairs as needed.

Fair condition.
Corrosion was noted under the faucet. A licensed plumber should be called to make further evaluation and repairs as needed.

Due to the leak and corrosion at the faucet and the waste line straps which were disconnected or damaged, we recommend that they be repaired/replaced by a licensed plumber.

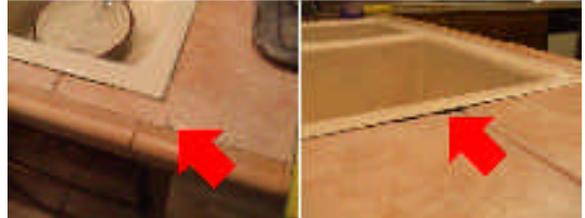
Fair condition. Counters are tile. Minor wear or cracking was noted to the counter surface. Grout/caulking is missing in some areas. We recommend that these areas be properly sealed to prevent any future water damage.

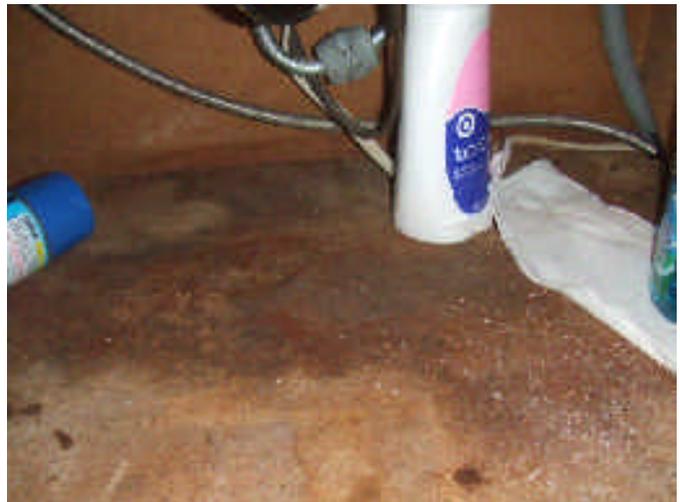
Staining from a past leak was noted under the sink. We recommend that corrections be made by a licensed plumber.

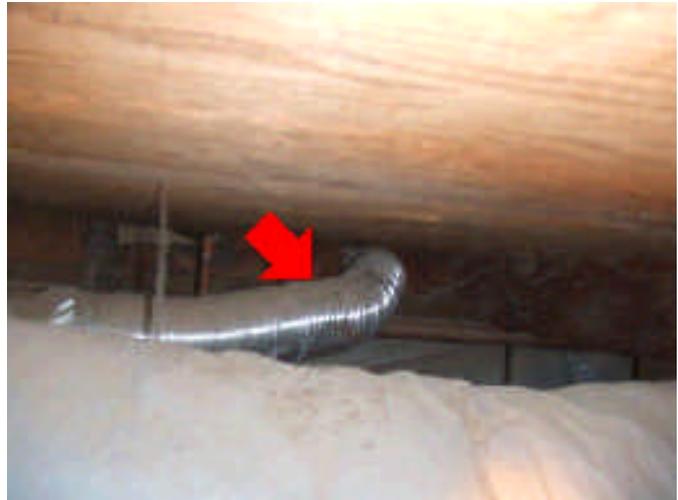
The dryer vent under the home is non-conforming to current standards as the pipe is flexible metal or (plastic). Smooth wall "K.D." pipe is suggested and will help with the drying efficiency of the unit.

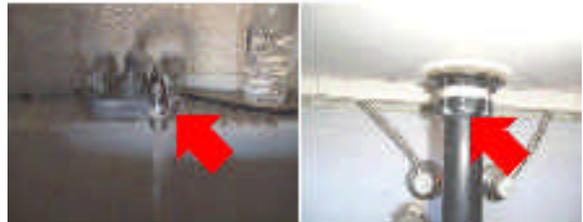
A leak was noted under the laundry sink at the P-trap. We recommend replacing the gaskets at the connections as a first attempt of correction.

SINK(S): Fair condition. A leak was noted under the sink at the P-trap. We recommend replacing the gaskets at the connections as a first attempt of correction.

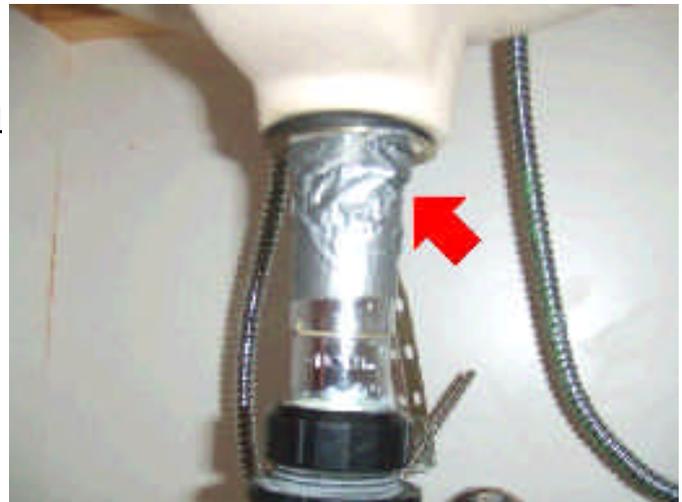
SINK: Fair condition.
Stainless Steel.
Unprofessional repairs were noted to the bathroom waste lines.

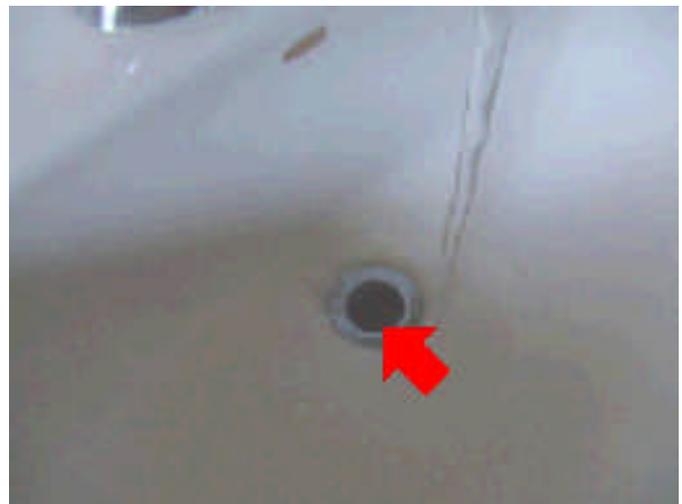
FAUCET(S): Fair condition.
NOTE: The stopper mechanism was missing at the sink.

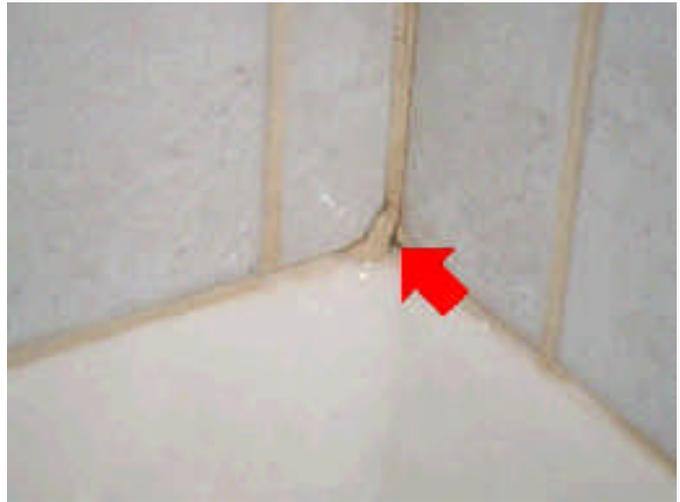
The shower floor-to-wall seal is starting to deteriorate. We recommend removing the old caulking or grout and re-applying. Do not delay making these repairs to prevent future damage.

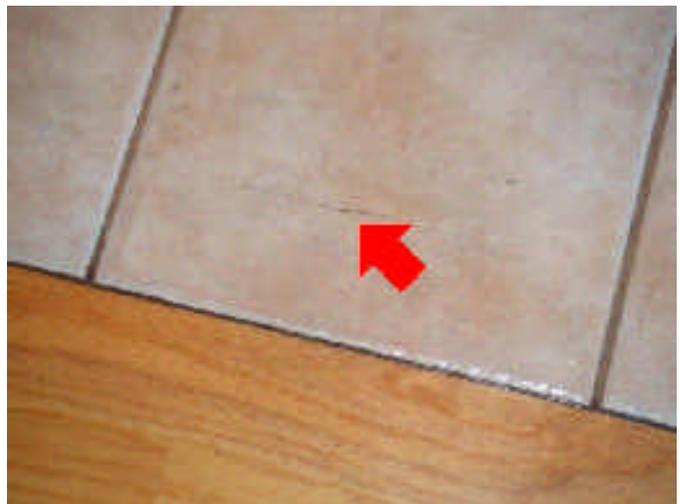
Fair condition.
The floor covering material is wood.
Ceramic or glazed tile. At least one tile was noted to be cracked or damaged.

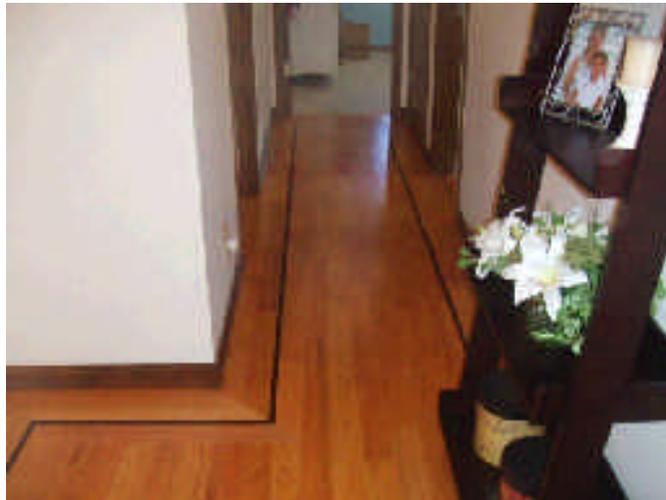
The floor in the hallway is slanting towards the bathroom and needs some repair, but due to the covering it is not possible to determine the extent of the repairs needed. Therefore, we recommend that a licensed contractor further examine and make corrections as necessary.

Fair condition.
Limited Visibility.
The floor is slanting towards the bathroom and needs some repair, but due to the covering it is not possible to determine the extent of the repairs needed.
We recommend that a licensed contractor further examine and make corrections as necessary.

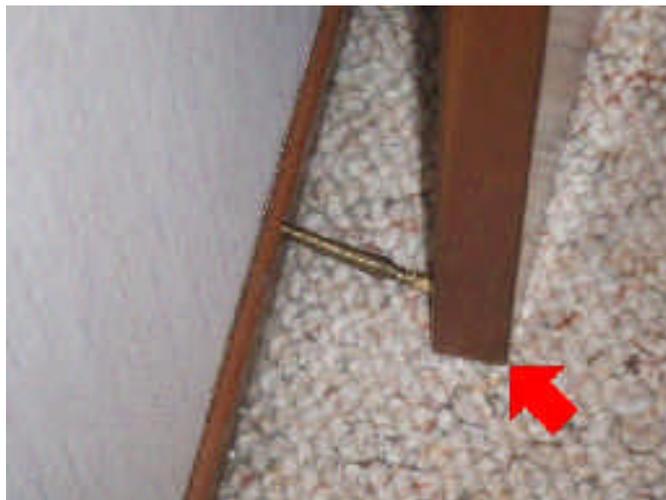
DOORS: Fair condition.
The door rubs on the floor when opening.
Trimming adjustments are suggested. Door is missing door stop. We suggest installing a door stop to ensure that no potential wall damage occurs.

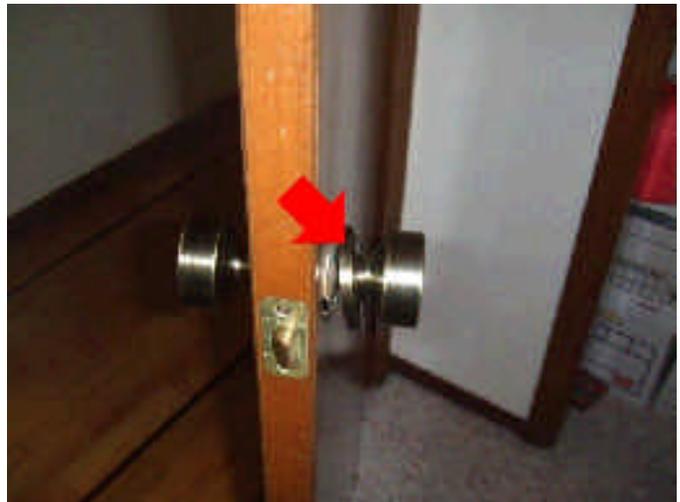
The handle/lock assembly is loose and needs repair.

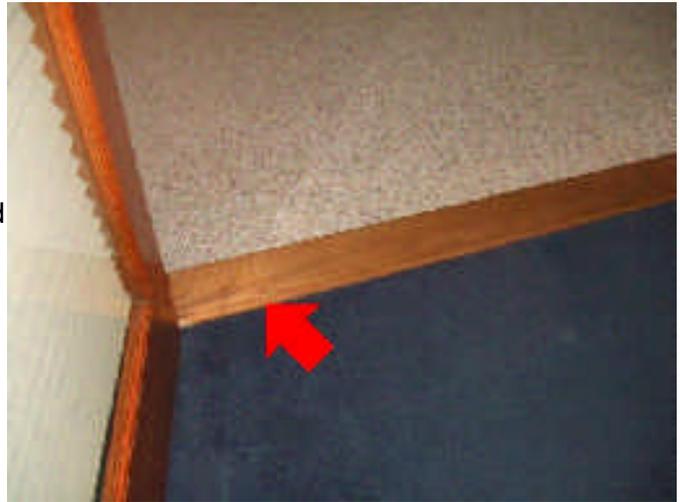
Fair condition. The transition board between the master and bonus rooms was not secured to the floor. As this could be a **potential tripping hazard**, we recommend this board be secured to the floor.

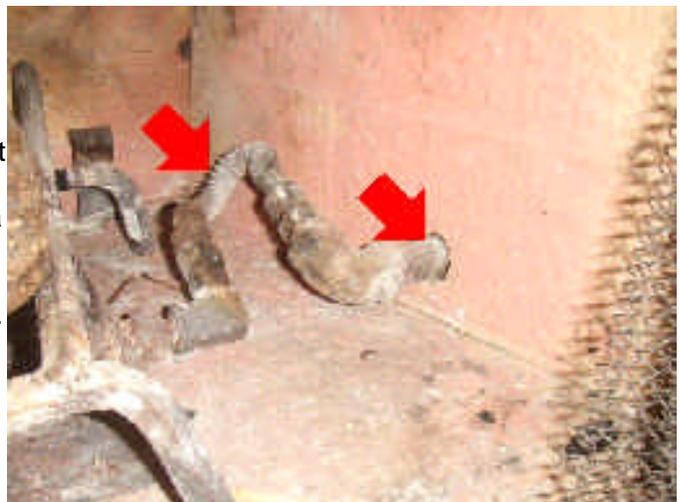
Inspection shows the fireplace gas line to be connected with a flex tubing. Current standards require the installation of a gas log to be made with a black or galvanized pipe. We recommend replacing this item with solid piping to conform with current building practices.

Fair condition. Inspection shows gas line to be connected with a flex tubing. Current standards require the installation of a gas log to be made with a black or galvanized pipe. We recommend replacing this item with solid piping to conform with current building practices. The opening around the gas line as it enters the firebox should be sealed with either a fireplace mortar or a fireproof sealant to prevent possible flame entry into the area behind the firebox.

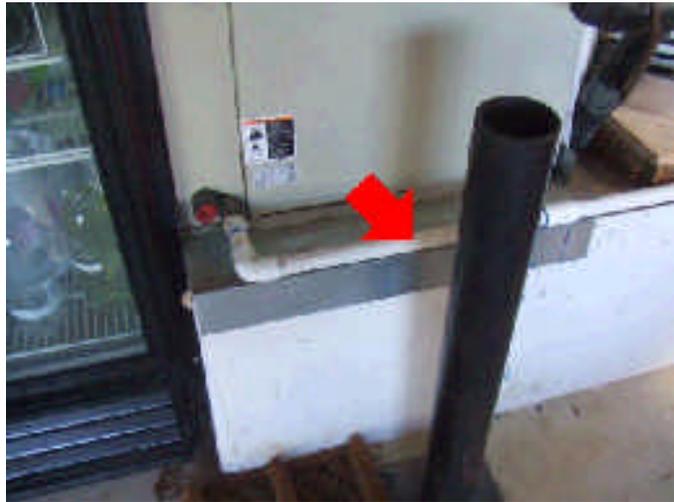
OVERALL CONDITION: Fair condition.
NOTE: A P-Trap was missing off of the condensation line. To increase the efficiency of the unit, we recommend that one be installed.

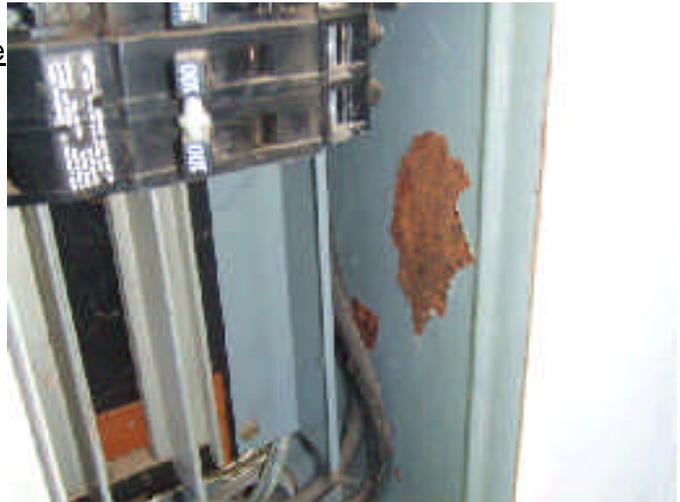
Corrosion was noted on the inside of the panel.

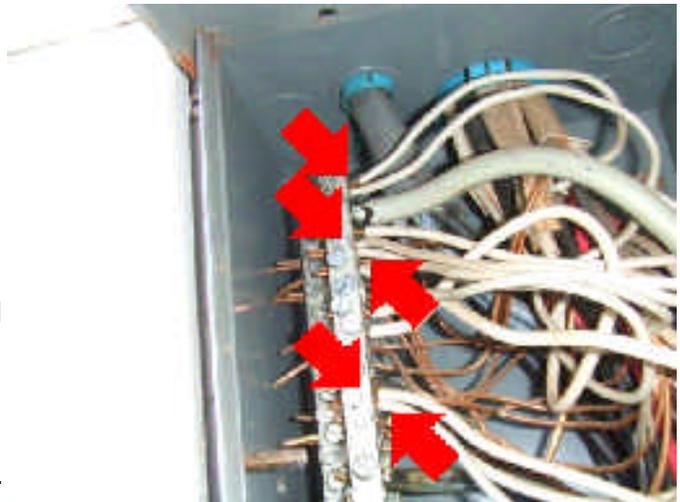
Multiple wires are connected at one or more of the neutral bar lugs. Panel manufacturers recommend that only one neutral wire be secured under each neutral lug bar. This provides extra safety to repair and adds a more secure connection. Consideration should be given to having a licensed electrician reposition one wire so that no more than one is secured under each lug.

should be given to having a licensed electrician reposition one wire so that no more than one is secured under each lug. Circuit and wire sizing correct so far as visible.

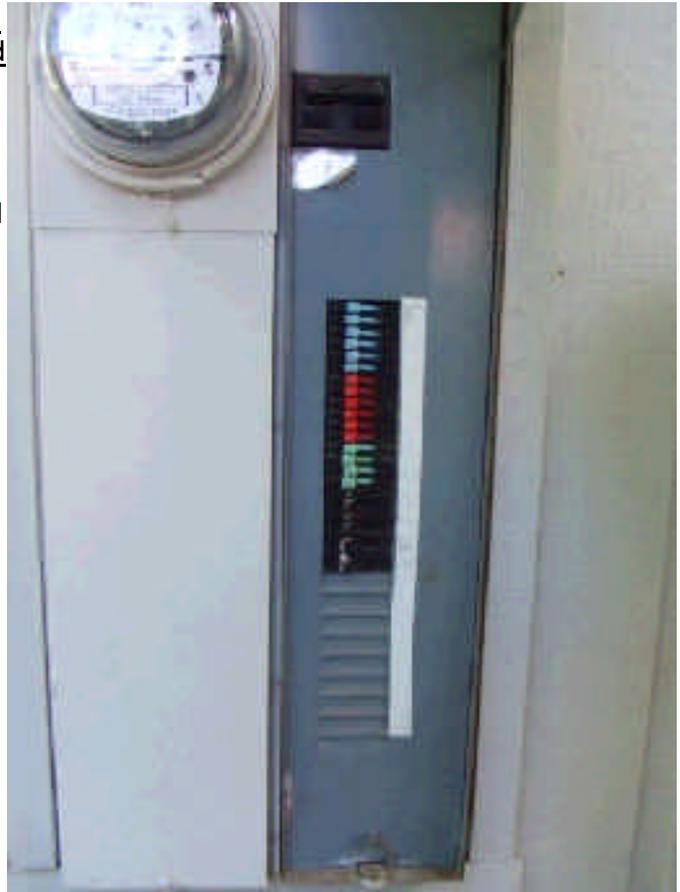
The electrical main service panel is a ZINSCO brand panel. Zinsco panels and breakers are no longer manufactured, and replacement breakers are very expensive. There is evidence that these panels and breakers are less than reliable, and have proven to not trip when overloaded, which could cause a **hazardous condition**. It is beyond the scope of home inspections to remove the breakers for a more thorough inspection. All electrical equipment has a limited life and degrades with age. Based on these factors, we recommend having a licensed electrician further examine this panel, and make their own recommendations. Additional information can be found at www.inspect-ny.com/electric/zinsco.htm.

NOTE: This panel is a ZINSCO brand panel. Zinsco panels and breakers are no longer manufactured, and replacement breakers are very expensive. There is evidence that these panels and breakers are less than reliable, and have proven to not trip when overloaded, which could cause a **hazardous condition**. It is beyond the scope of home inspections to remove the breakers for a more thorough inspection. All electrical

equipment has a limited life and degrades with age. Based on these factors, we recommend having a licensed electrician further examine this panel, and make their own recommendations. Additional information can be found at www.inspect-ny.com/electric/zinsco.htm.

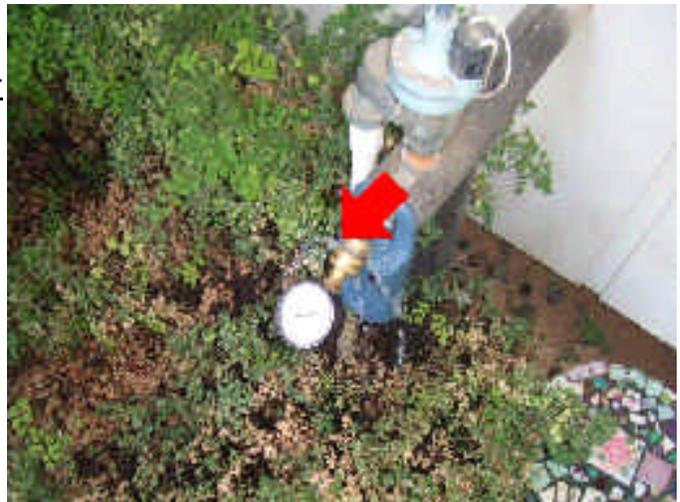
The front hose bib near the fountain was leaking. Replacement is recommended.

Good to fair condition. The front hose bib near the fountain was leaking. Replacement is recommended.

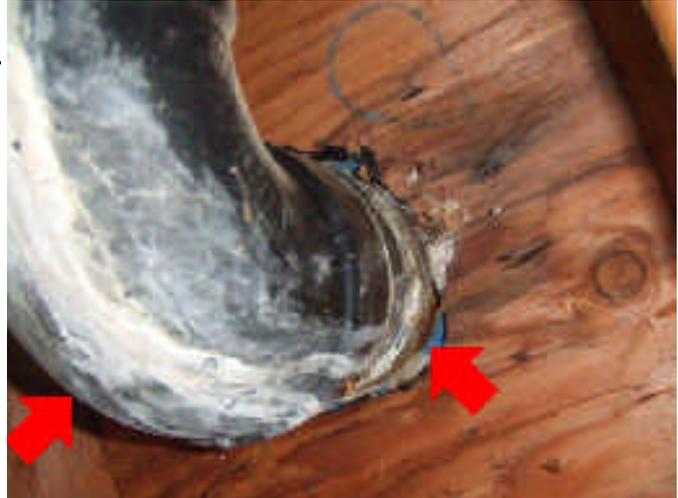
NOTE: Stains from a prior leak were noted under the master toilet.

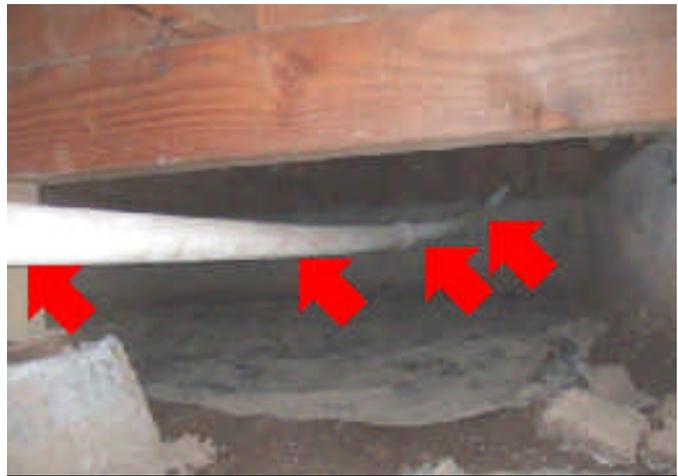
Missing supports for sump discharge line

The sump pump line was not adequately supported. To prevent breakage of this line, we recommend that strapping be attached, no more than 4 feet apart.

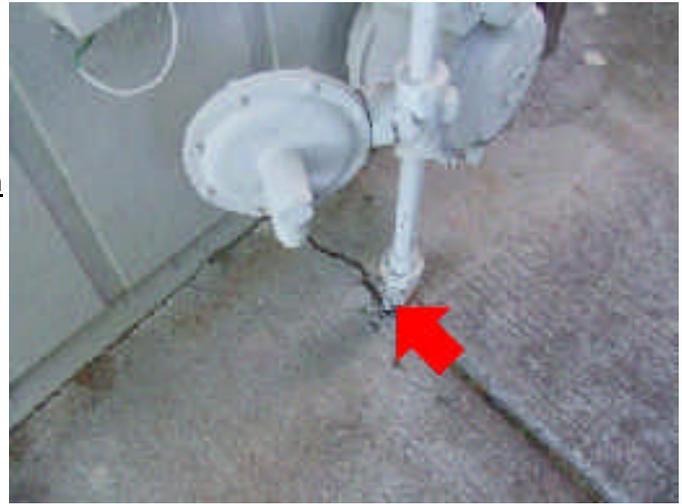
Gas valves are often very difficult to turn without a wrench of at least 10" long, we suggest that a wrench be fastened within

easy reach of this gas valve for use in the event of an emergency.
