Home Inspection
Prepared for: Rich and Dayna Lee

8/11/2006

128 Palo Verde Court
Sonoma, CA 95476

Valley Inspections
(707) 332-0030

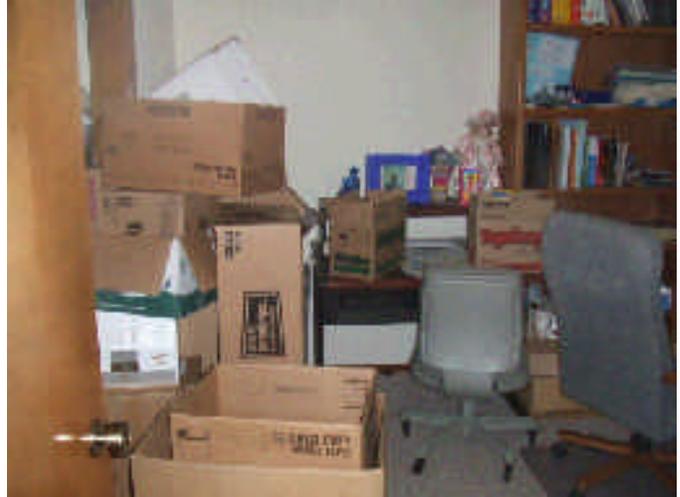
LOCATION:

Left Center. We were unable to fully view due to stored items or furniture.

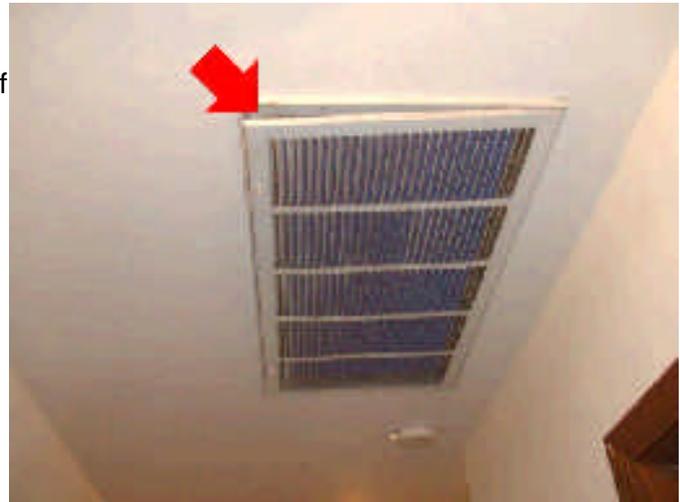
Damage was noted to the return air grill. Also noted was the return air duct and grill were undersized for the H.V.A.C. systems. To increase the efficiency of the system we recommend repair or replacement be made by a licensed H.V.A.C contractor.

Damage was noted to the return air grill. Also noted was that the return air duct and grill were undersized for the H.V.A.C. systems. In order to get the maximum efficiency of the system, we recommend repair or replacement be made by a licensed H.V.A.C contractor.

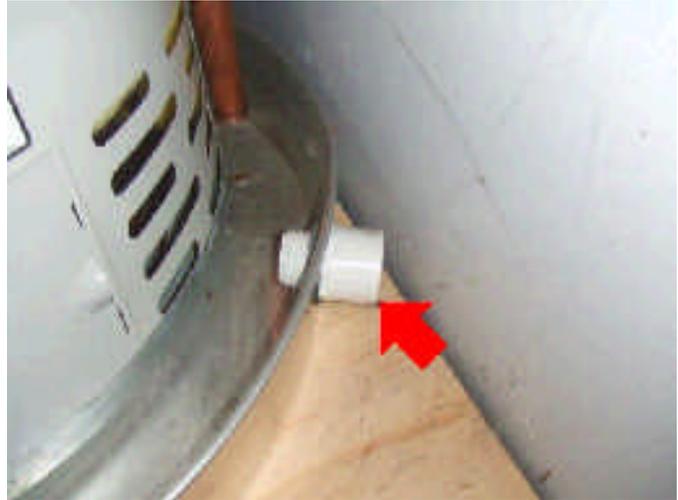
NOTE: Although a pan was installed underneath the water heater, consideration should be taken to having a licensed plumber run a secondary drain line off of this pan to an exterior location, should a leak occur.

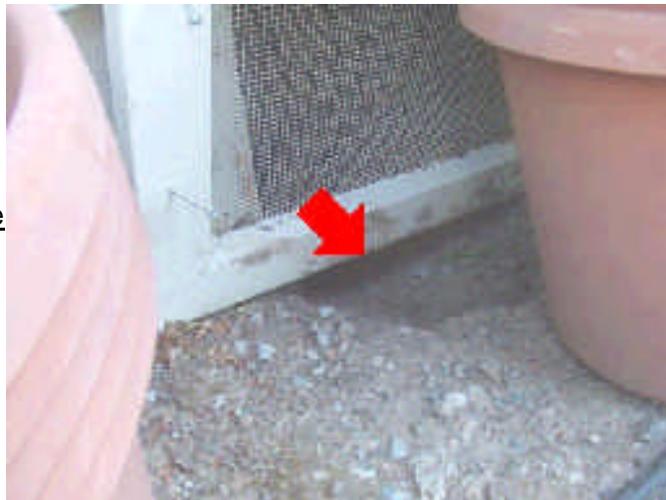
Upon further inspection in the crawlspace of this rear access hole, rodent traps and what appeared to be a skunk odor was noted. We recommend that a licensed exterminator further examine and make corrections as necessary.

Therefore we recommend that this door be

replaced with one that will fully cover the access hole.
